**INTEGRATION OF GEOREFERENCED INFORMED SYSTEM AND DIGITAL IMAGE
ANALYSIS TO ASSES THE EFFECT OF CARS POLLUTION ON HISTORICAL CITIES.**

R. Ortiz^{*a}, P. Ortiz^a, M.A. Vázquez^b, J.M. Martín^a

^aUniversidad Pablo de Olavide, Department of Physical, Chemical and Natural
Systems. Carretera de Utrera Km 1, ES-41013 Sevilla, España

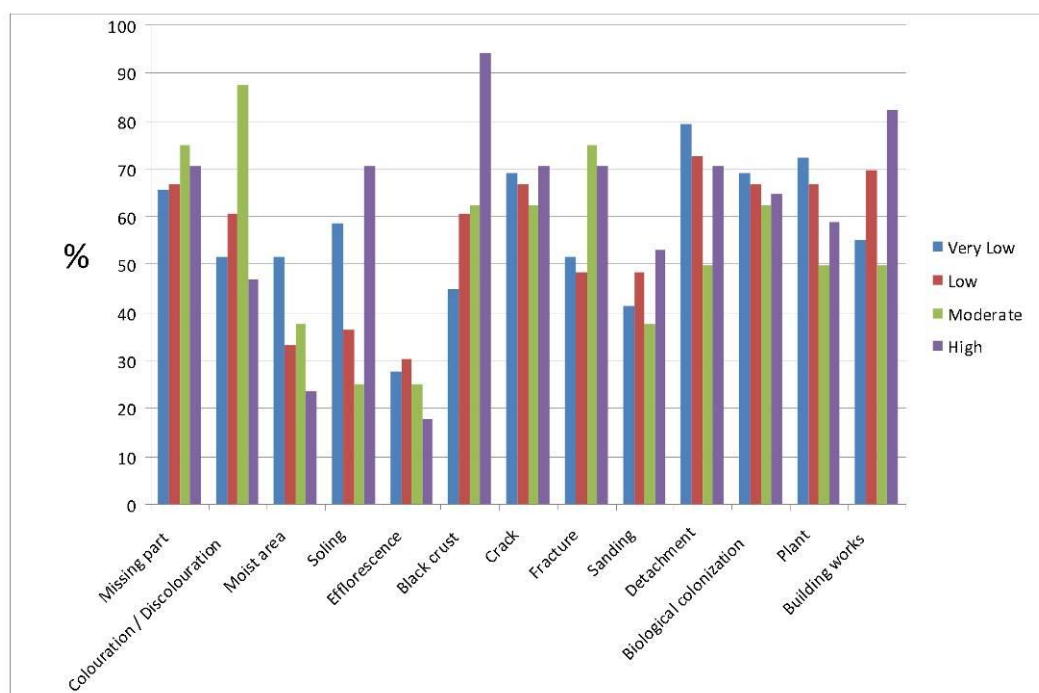
In Figure 2, a direct relationship is observed between the level of traffic and the weathering form by black deposits. Streets with very high levels of traffic were excluded because no monuments were found on these roadways. For streets with high or medium levels of motorised vehicle traffic, deposits are present on 94 and 62 % of the facades, respectively, whereas for facades on streets with low vehicle transit, the presence of deposits decreases considerably ($< 45\%$). Approximately 60 % of monuments on streets with medium levels of traffic exhibited deposits, which is relatively higher than what would be expected, likely due to the influence of narrow streets because vehicles circulate in closer vicinity to the facades; however, the incidence of deposits may also depend on the time since the last restoration.

Black crusts are plainly visible and may be observed more easily on streets with a high density of circulating traffic and on narrow streets where traffic circulates in closer proximity to the facades.

Figure 2. Frequency of weathering forms at the studied churches according to level of traffic.

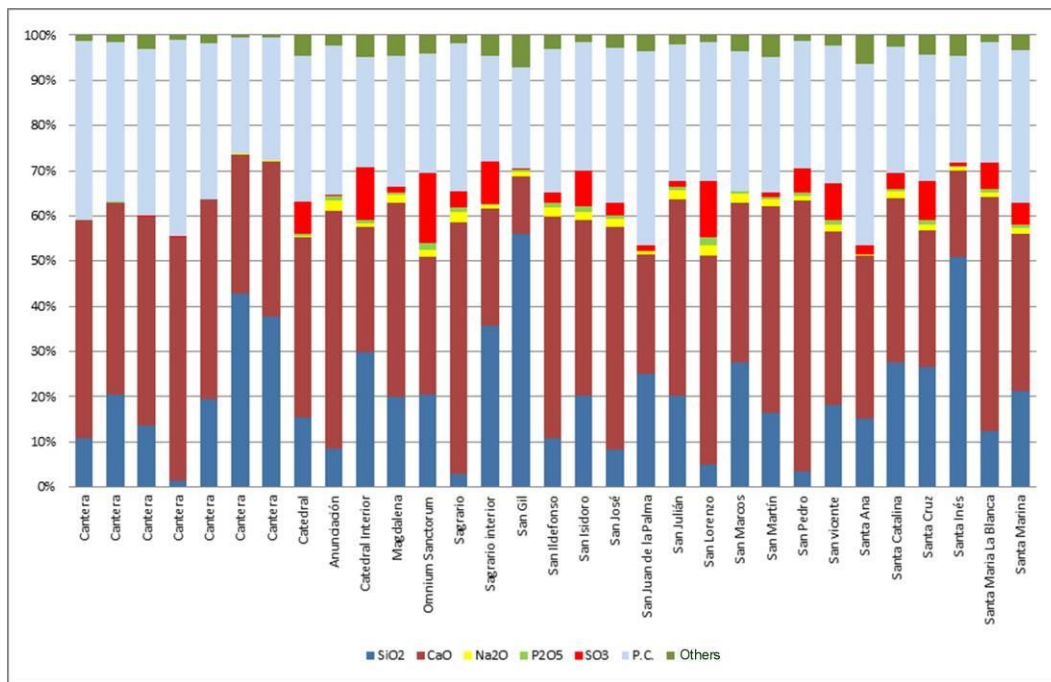
The chemical analysis of crusts and deposits was also assessed by x-ray fluorescence (XRF; Figure 3). Calcium oxide (CaO) was found at high concentrations by XRF and formed a major component in 75 % of the samples; this compound is associated with calcite in rocks and mortars. The silicon content varied by sample, according to the nature of the construction material, with higher values corresponding to mortars. The CaO content associated with losses

due to calcination implies that the majority of samples have a high level of calcium, which is in agreement with the XRF results from construction materials. This predominant chemical-mineralogical composition of the building materials of the architectural heritage of Seville implies high vulnerability to air contaminated with sulphur and nitrogen oxides under the local meteorological conditions [49]. In this case, calcite also tends to react easily with atmospheric sulphur oxides to form gypsum on the building surface, generating a black crust. Of the 90 samples of crusts and deposits analysed by XRF, more than 80 % had SO₂ content above 1 % (Figure 3), which is considered to be a high level of sulphur because the samples analysed from the quarry do not contain this component at all or it appears in quantities of less than 0.05 %. This percentage of samples with SO₂ confirms the formation of gypsum (CaSO₄·2H₂O) to be a consequence of the reaction of the calcium carbonates of the facade materials with polluting sulphur gases in the environment. In 75 % of the samples, this alteration is associated with a sulphur oxide content greater than 1 % W/W, whereas the remaining portion is due to the alteration of joints, repositioning of mortars or the capillary ascension of moisture.

Figure 3. Chemical composition analysis of crusts and deposits determined via x-ray in comparison with samples of quarries. (Percentage %W/W). Note: PC corresponds with loss due to calcination.

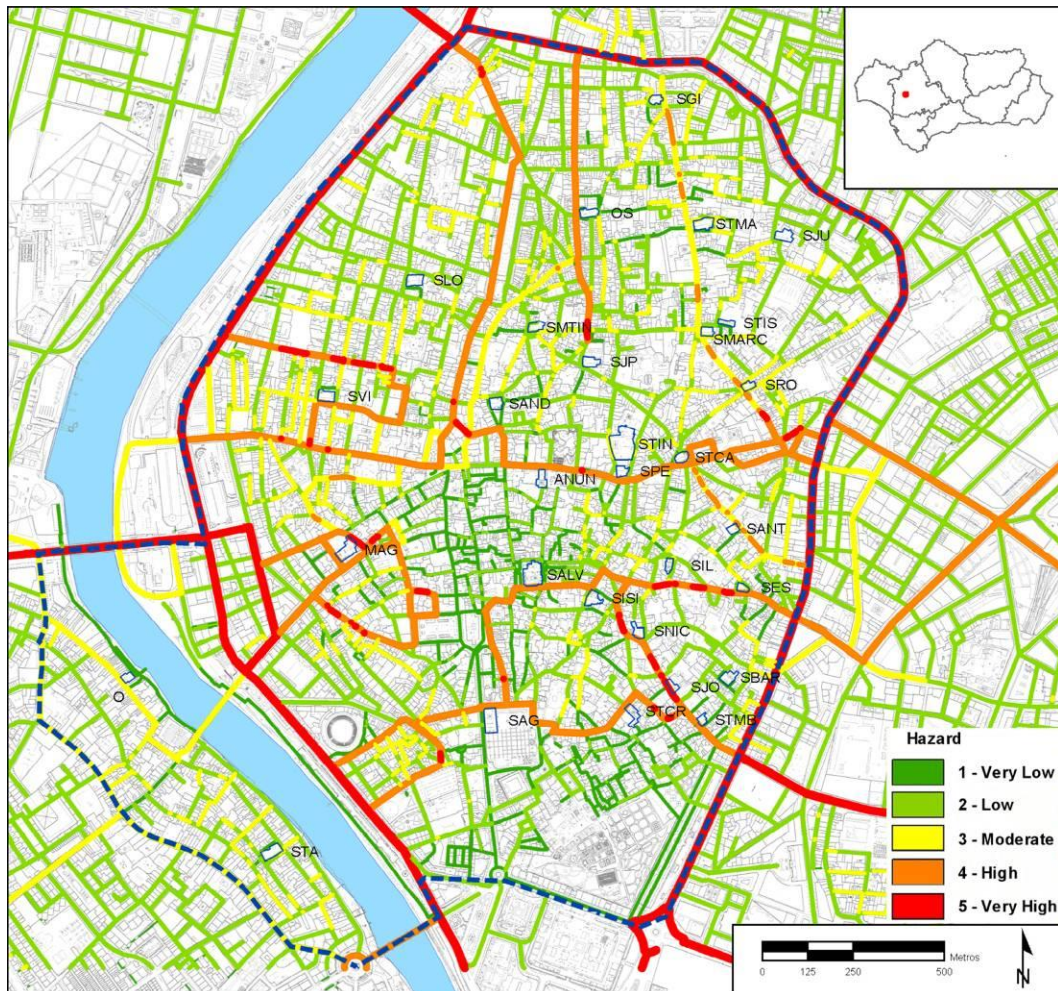
This hazard map shows levels of vehicular traffic in Seville, according to the criteria established in the PGOU [41]. Roadways are classified based on the following levels of traffic: structural, the loop around the historic centre with high levels of traffic (hazard factor 5, red); medium (hazard factor 4, orange), characterising the entrance and exit ways of the historic centre; streets limited to public transportation (hazard factor 3, yellow); pedestrian streets with low traffic (hazard factor 1, dark green); and the remaining streets with limited

circulation, classified as low traffic (hazard factor 2, light green). This hazard map (Figure 6) suggests that facades facing streets with higher levels of traffic have a greater probability of developing black crusts and deposits.

Figure 6. Pollution hazard map due to traffic in the historic centre of Seville (Spain)

The loop, which has very high levels of traffic, is located relatively far from the most emblematic monuments of the city. Several of the studied church facades are located along the entrance and exit ways of the historic centre, which have high levels of traffic, and may continue to be affected, such as Santa Catalina, San

Pedro, Anunciación, San Vicente, Omnium Sanctorum, Salvador, San Isidoro, San Esteban, San Nicolás, San José, Santa María la Blanca, and la Magdalena. Meanwhile, the rest of the facades are located along circulation routes considered to have very low, low or medium hazard.

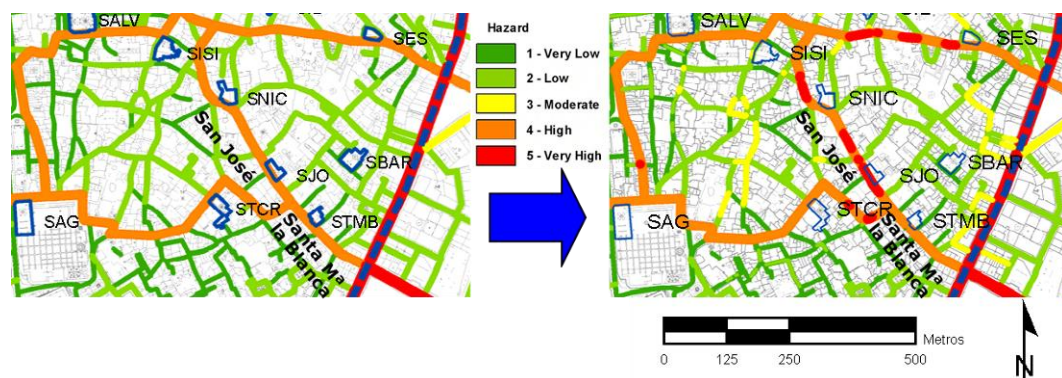
The hazard map (Figure 6) may be further enhanced by including the effect of streets with widths ≤ 5 m between opposing facades. The close proximity of circulating traffic to facades accelerates their blackening and represents an increased hazard. In the modified hazard map below, street width less than 5 m represents an additional factor and increases risk by one unit. For example, the street San José as well as its extension, the street Santa María la Blanca (Figure 7), are exit routes from the centre where San Jose church is located, which is on a street ≤ 5 m in width. Therefore, hazard increases from high to very high for that facade (Figure 7). This church has a facade sealed with stone that is visibly damaged due to the effects of black crusts/deposits.

Figura 7. Detail of the traffic hazard map near the streets San José and Santa María la Blanca.
